Walker Quarries

ANNUAL REVIEW

For the Period 1 July 2021 to 30 June 2022

Prepared by
Umwelt (Australia) Pty Limited
on behalf of
Walker Quarries Pty Ltd

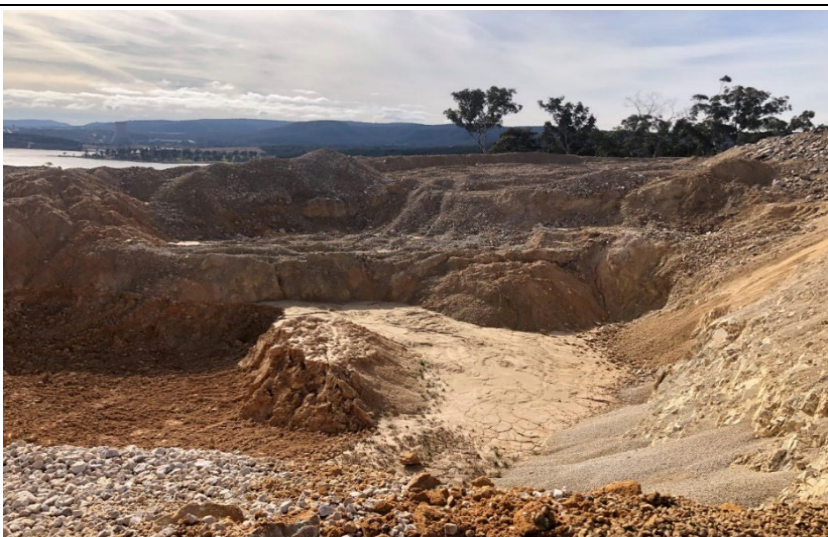
Photo 4.3 **Mining Area 2**
– Northern Limit

2. Extraction of lower value (lower silica concentration) material by dozer ripping, for sale as select fill, from the northern section of the pit (to the south of the silt cells and access road to the eastern side of the pit) to an elevation of approximately 955 mAHD (refer to **Photo 4.3**).

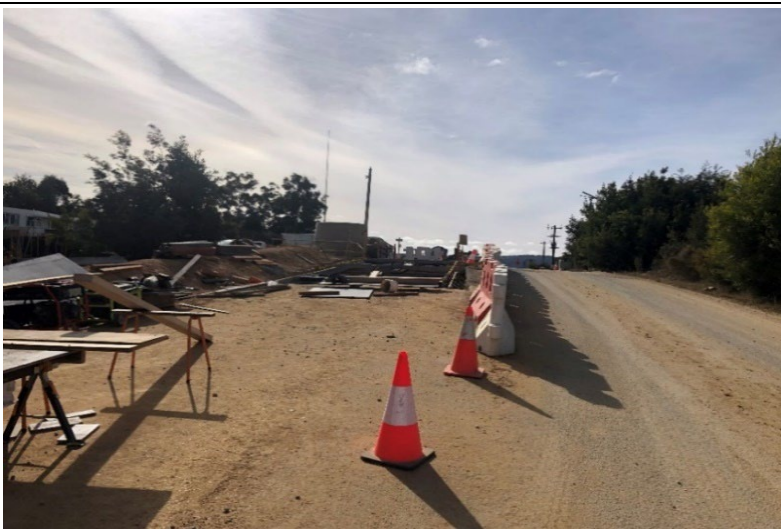
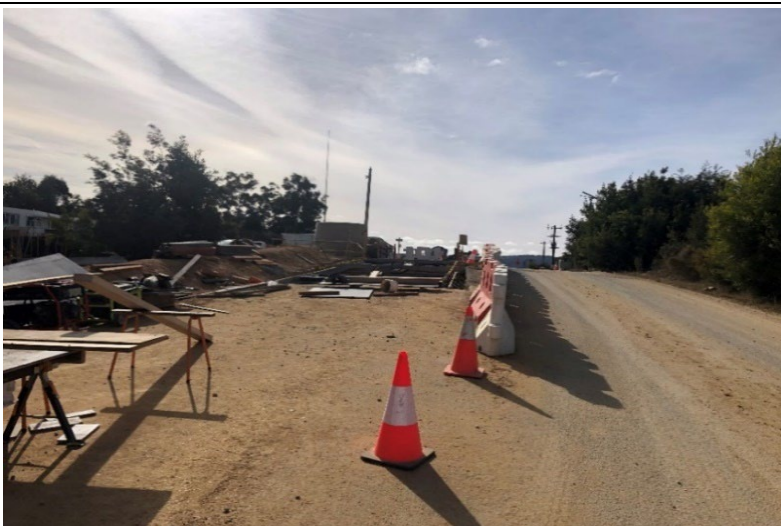
Photo 4.4 **Weighbridge upgrade**

A planned upgrade to the truck wheel wash to improve prevention of dust tracking commenced in June 2022 (refer to **Photo 4.4**), and is scheduled for completion by September 2022.

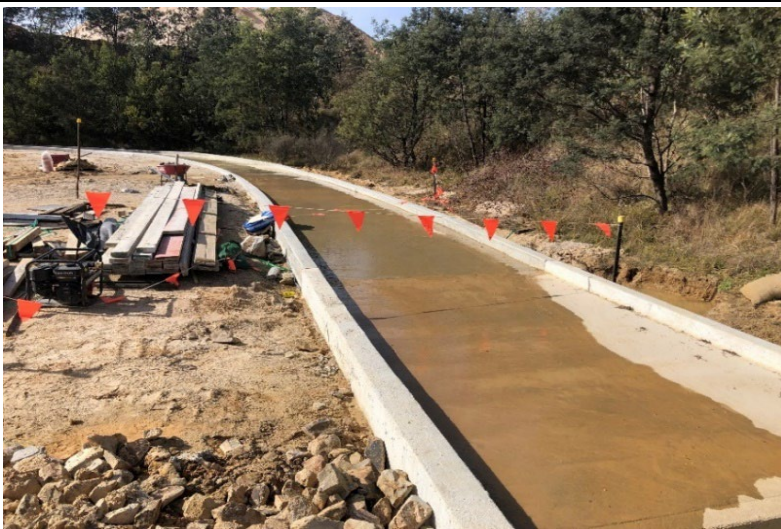
Photo 4.5 **Concrete Drain Construction**

The weighbridge upgrade also led to a review and reconfiguration of drainage from the Quarry Access Road, office area and internal haul roads. As a result, runoff previously directed to a small sediment basin to the east of the office area (SB5) is now diverted to SB1 on the Main Stockpile Area. To reduce erosion hazard, a concrete line drain was constructed to carry these flows (refer to **Photo 4.5**)

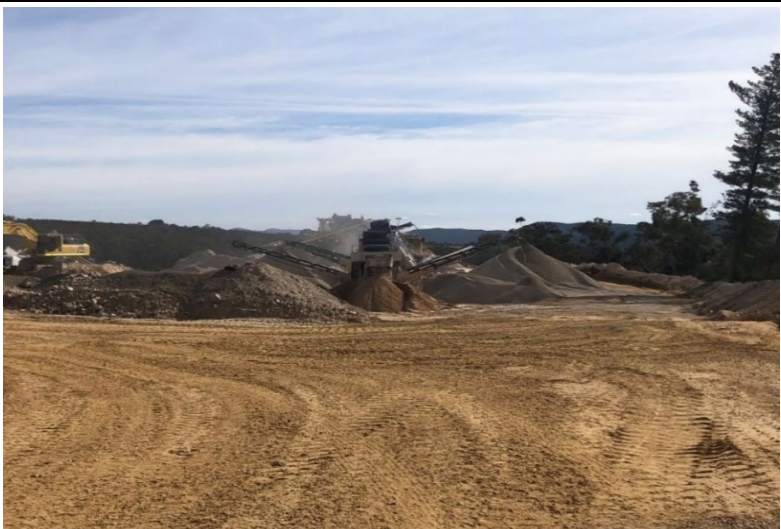
Photo 4.7 **In-pit Crushing
(concrete aggregates)**

The processing operations involve the use of a series of crushers and screens to crush, separate and wash the quartzite into various size aggregates and sands. During the reporting period, crushing and screening was undertaken in the extraction area (refer to **Photo 4.7**).

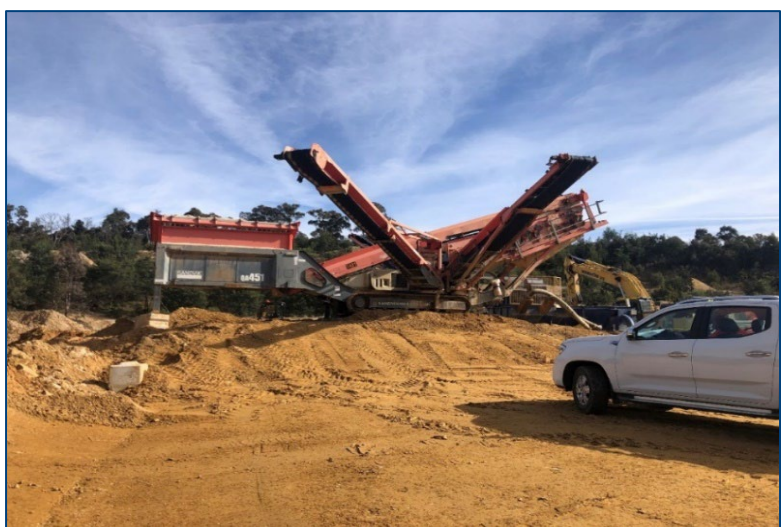
Photo 4.8 **Relocated
(Temporary) Wash Plant Location**

A sand washing plant was operated between July 2021 and February 2022 on the Processing Pad before being relocated to the Main Stockpile Area (to the north of a modified SB2) in March 2022 to accommodate the site preparation works of the wash plant upgrade commenced on the Processing Pad (refer to **Photo 4.8**).

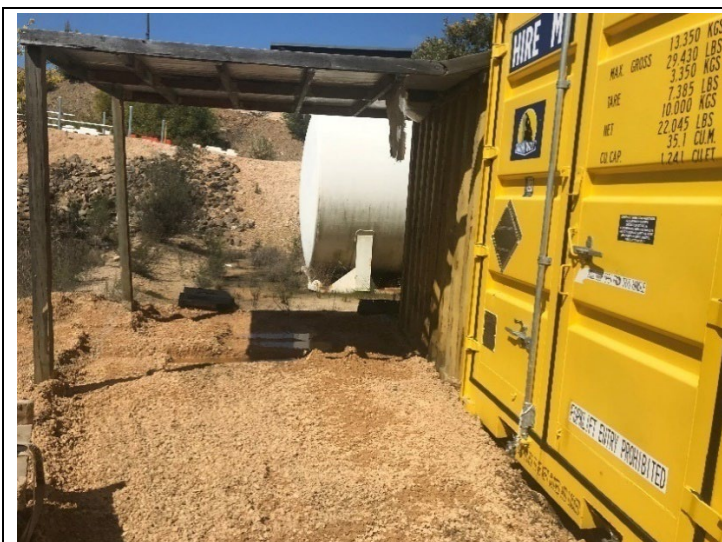
Photo 11.1 **Hydrocarbon clean-up**

Walker Quarries completed a clean-up of the ground where leaks and spills had occurred and has since installed a new fuel storage container allowing for all drums and IBCs to be appropriately contained (refer to **Photo 11.1** to **Photo 11.3**).

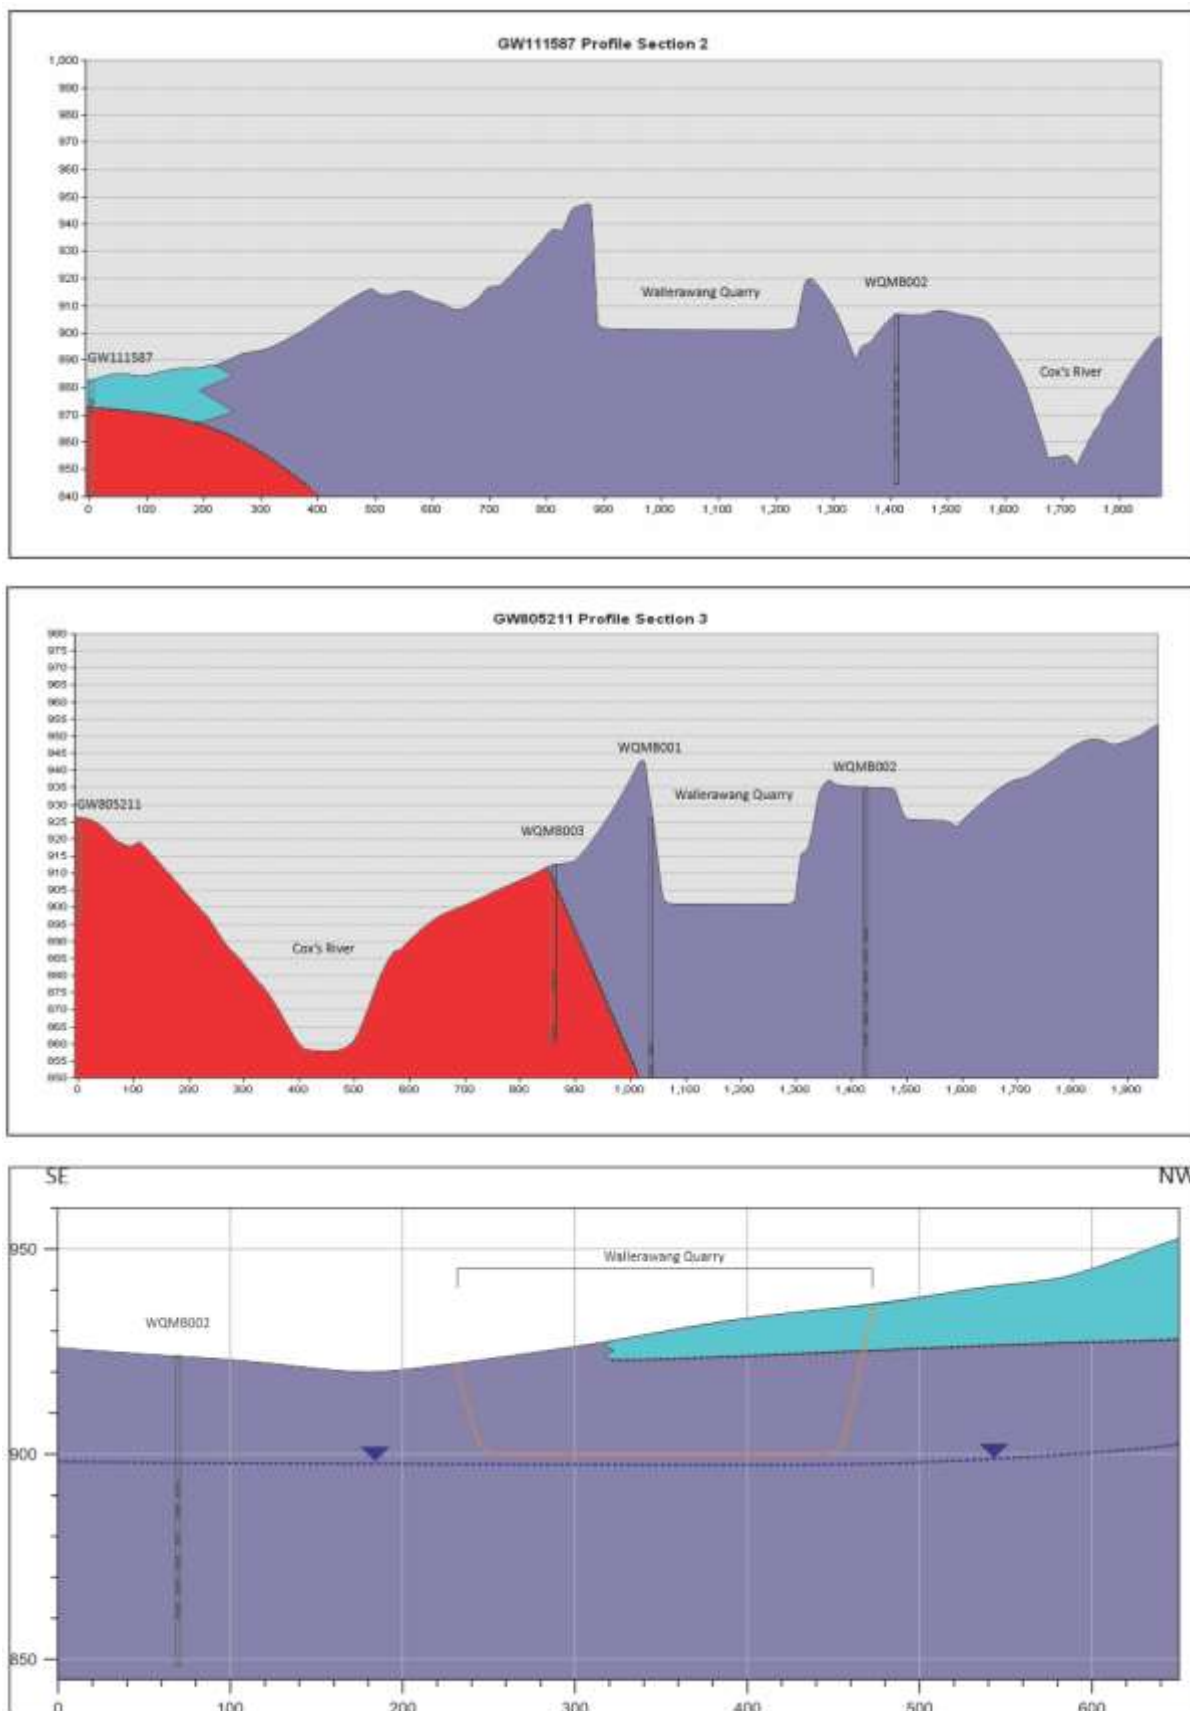
Figure 4: Wallerawang Quarry Plan and Profile Sections showing Groundwater Bores.

Figure 4 below shows a plan of the Wallerawang Quarry and profile sections with existing groundwater monitoring bores. The profile sections show that the Quarry is well above the level (RL) of the Cox's River.
