# Walker Quarries

## ANNUAL REVIEW

For the Period 1 July 2022 to 30 June 2023

Prepared by  
Umwelt (Australia) Pty Limited  
on behalf of  
Walker Quarries Pty Ltd

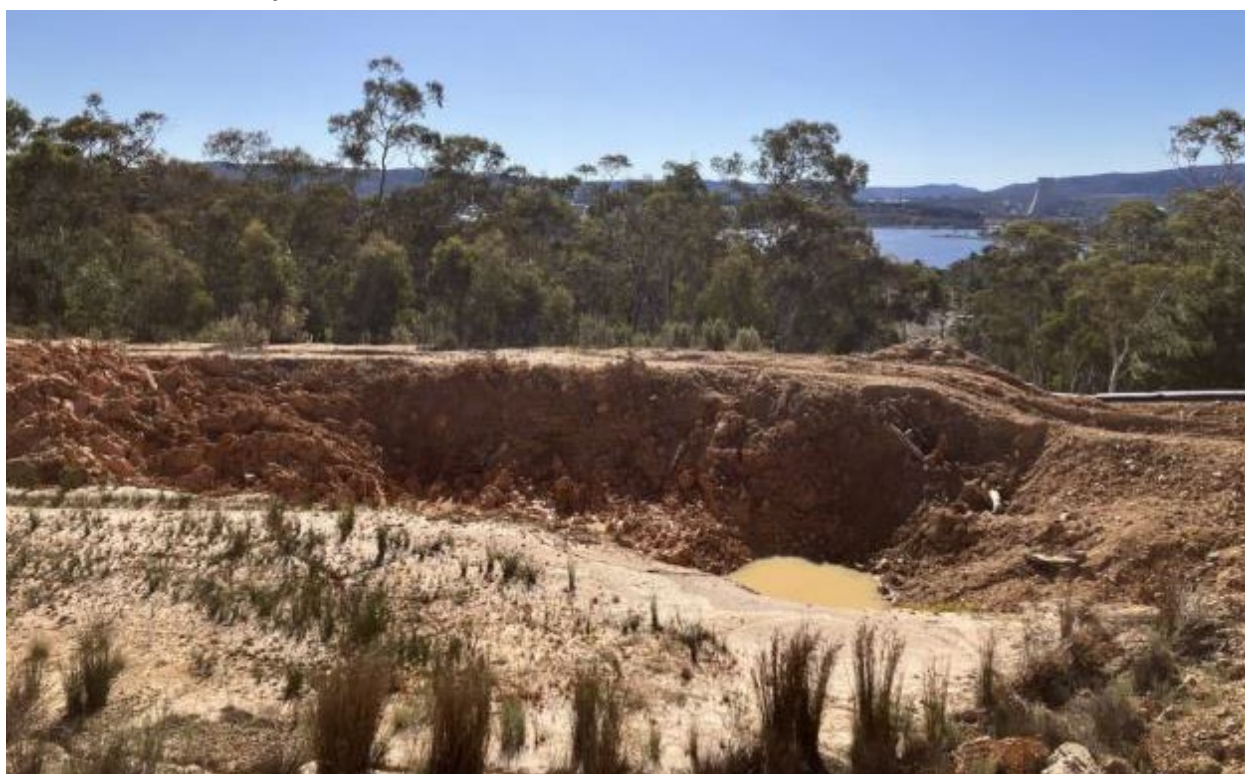
**Photo 4.2**      **Quarry Pit – Facing North**

The north easterly development of the extraction area proposed in the 2022 Forward Program was delayed due to a slower rate of extraction than forecast, resulting from changes to encountered in-pit geology.

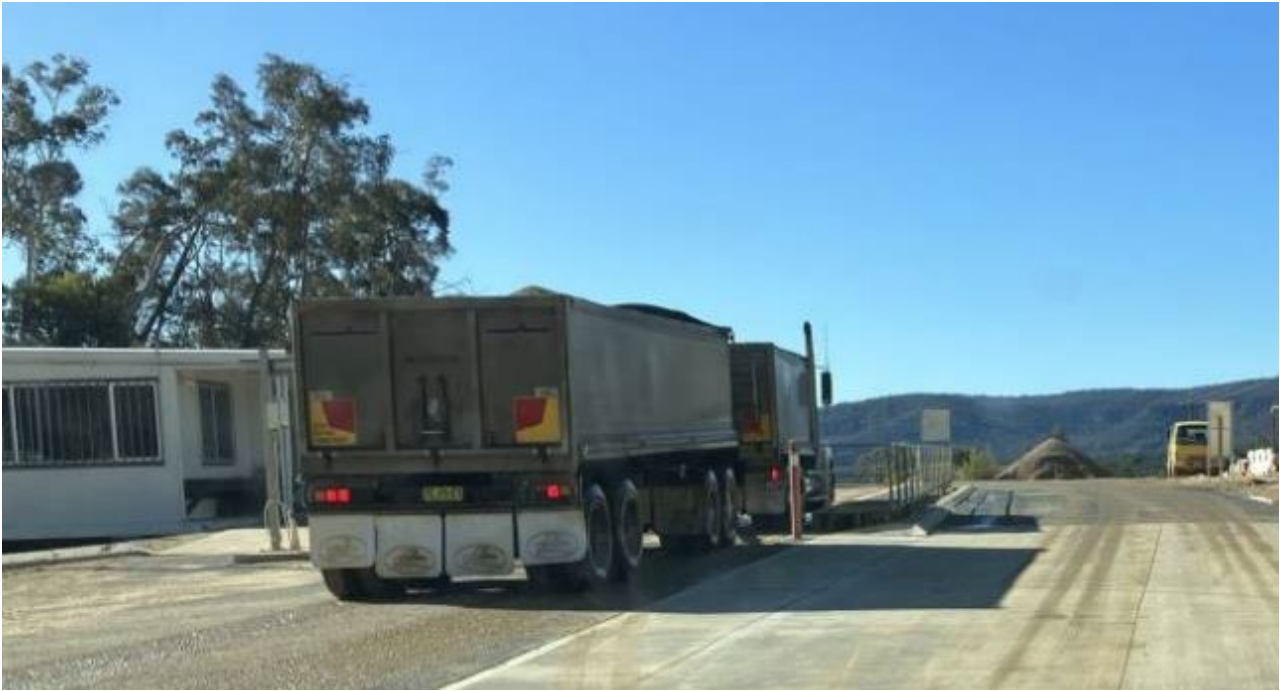
**Photo 4.3**      **Upgraded Wheel Wash**

With the construction of the new wheel wash, the flow and collection of water from the Quarry access road and office area was modified. As a consequence, there was no flow of water to SB5 which is now redundant. With the construction of the upgraded Wash Plant, the Top Working Dam (SB1) and silt cells to the north of the extraction area were also made redundant.

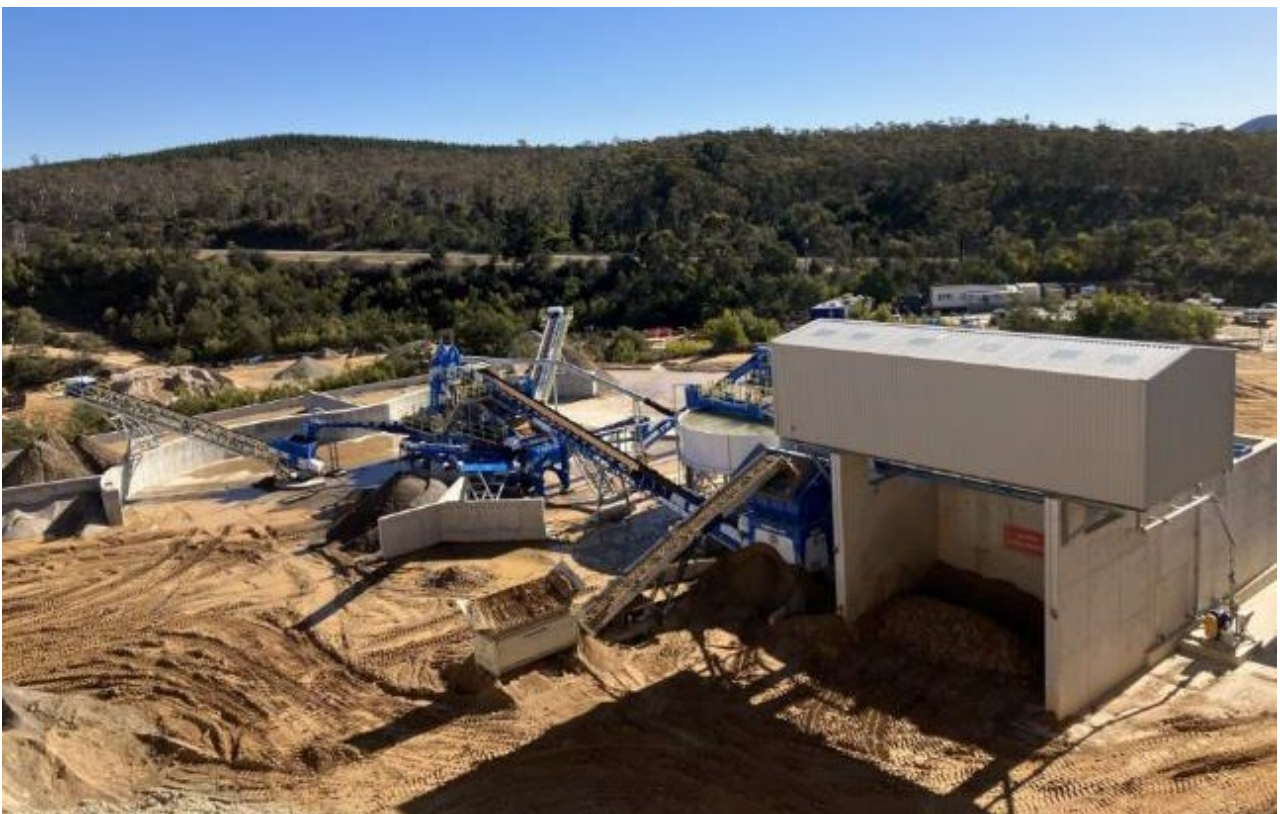
**Photo 4.4**      **Upgraded Wash Plant**

Construction associated with the upgraded Wash Plant (refer to **Photo 4.4**) was completed in February 2023. The upgraded Wash Plant, identified in the Statement of Environmental Effects (SEE) that supported Modification 3 was constructed as a fixed plant incorporating high efficiency dewatering components to significantly reduce the requirement to draw water, discharge and settle turbid water. The upgrade allows for the processing of the stockpiles of crusher dust/KIS Sand (currently located on the northern end of the processing pad) and production of a high demand manufactured sand product called McCluskey Sand (refer to **Section 4.3.2**).

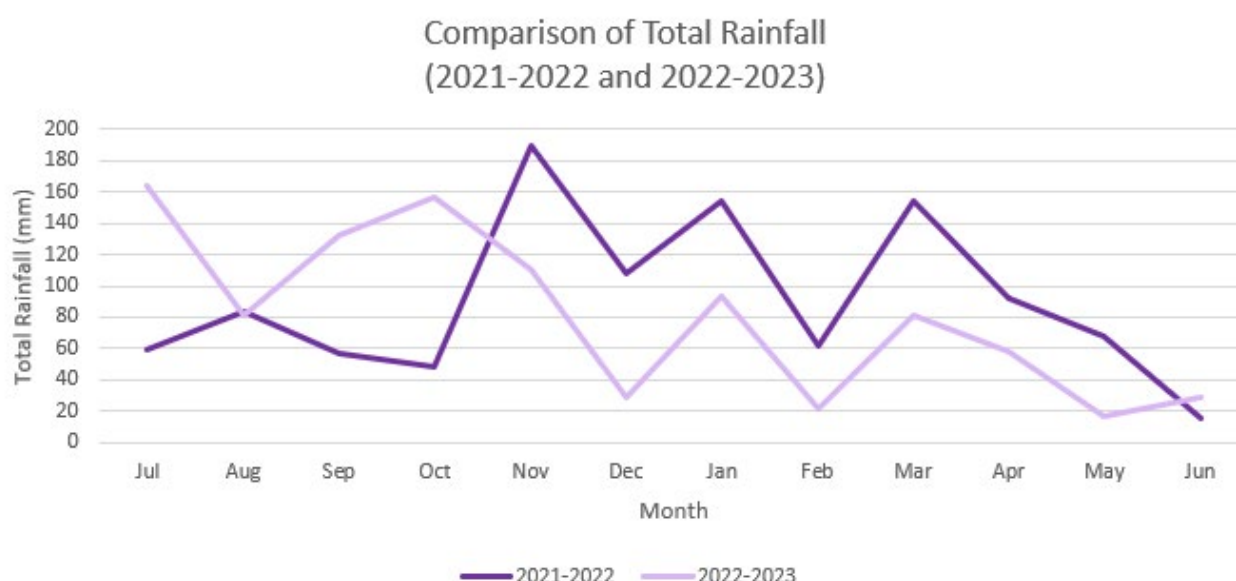
**Figure 6.3 Comparison of Total Rainfall**

This reporting period also experienced less annual rainfall (972.4 mm compared to 1080.8 mm in 2021/2022) and less rain days than the previous year (191 compared to 215 in 2021/2022).

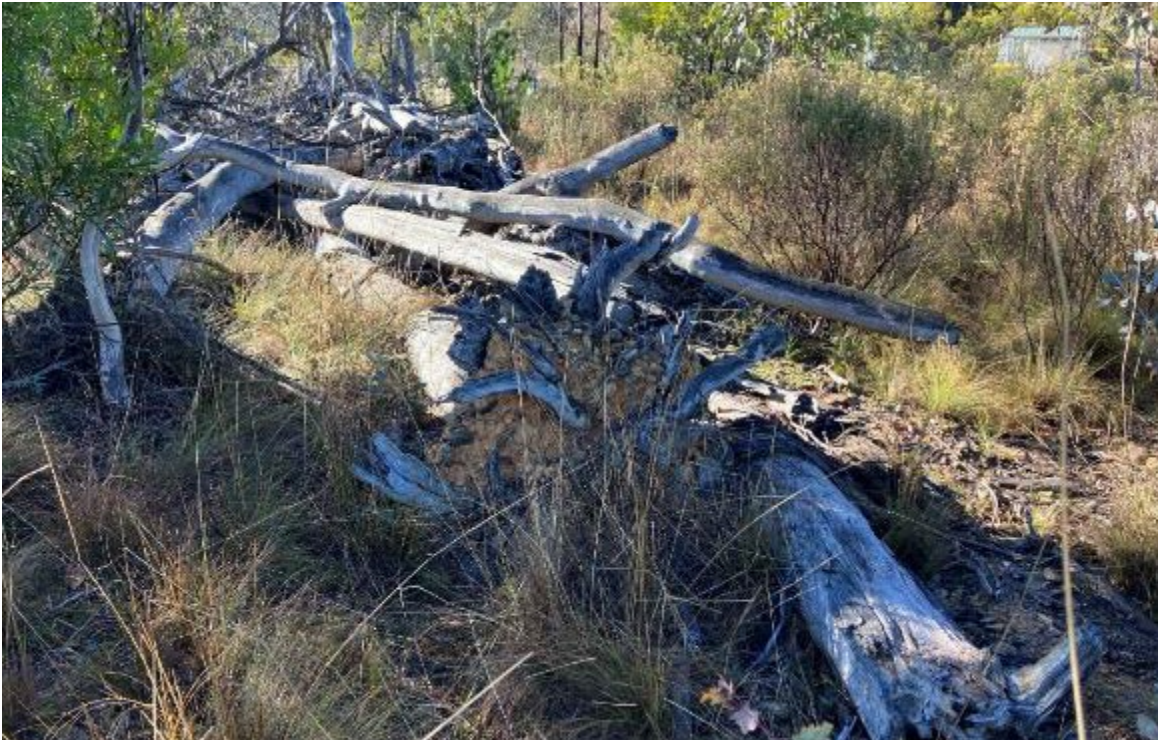
**Photo 6.1**      **Stockpile of Previously Cleared Vegetation for Rehabilitation Purposes**

Walker Quarries has retained a small stockpile of large landscape features such as major tree trunks, major tree limbs and minor branches in accordance with the RMP (refer to **Photo 6.1**). These features have the potential to create habitat with structural complexity to encourage a diverse range of native species into rehabilitated areas. This material will be used in future rehabilitation.

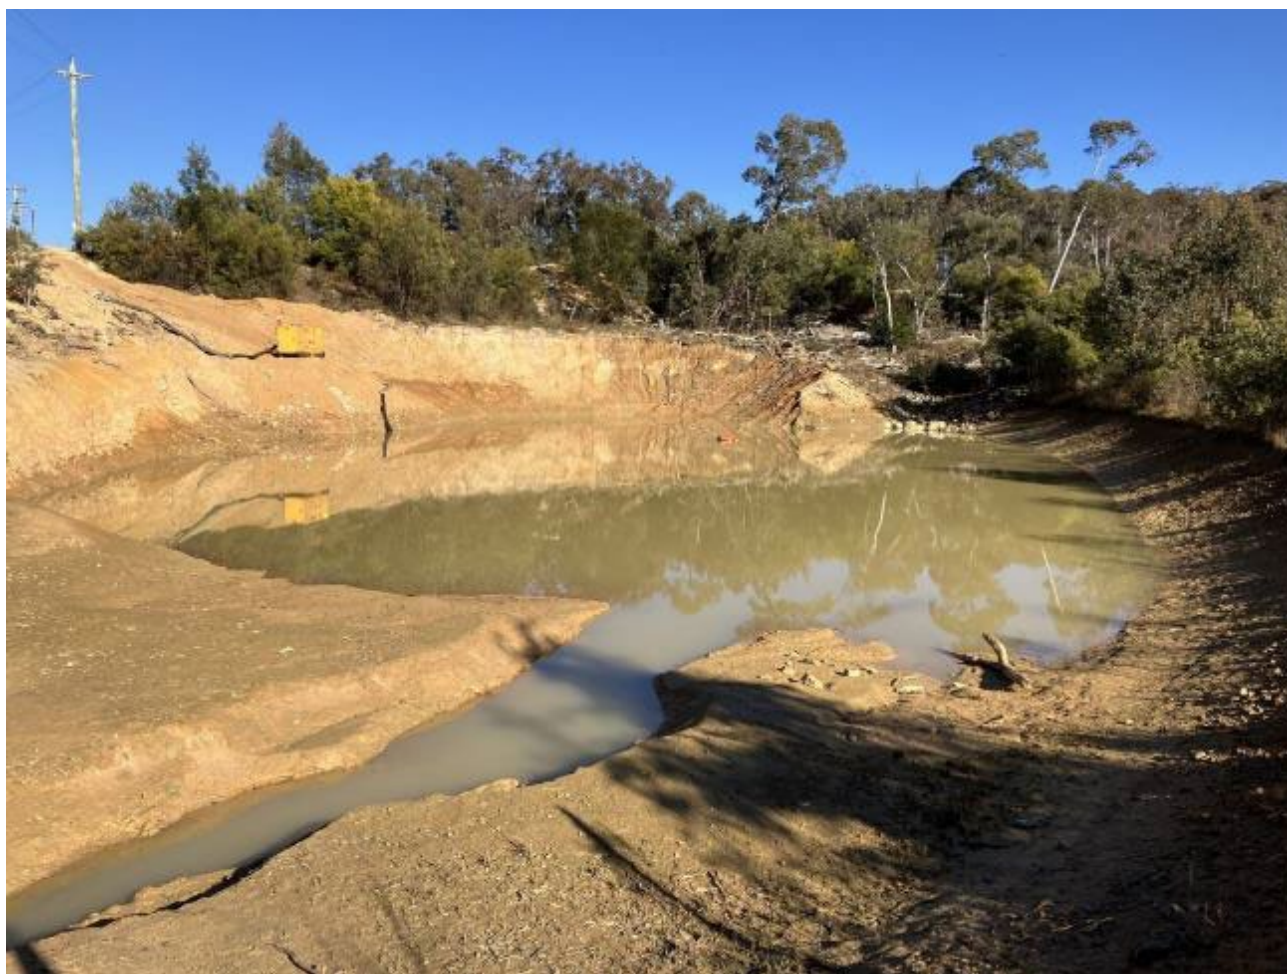
In the 2022 Annual Review, it was identified that the water storage capacity for SB2 had not been maintained as nominated in the SWMP. During this reporting period the storage capacity for SB2 was increased from 2.8 ML to 4.0 ML, to minimize the risk of discharge and with consideration of the loss of total dirty water storage capacity resulting from the impending removal of SB1. There were no discharge events during the reporting period.

The SWMP and Erosion and Sediment Control Plan (ESCP) state that sediment basins are to be maintained as 'dry structures' to maintain storage capacity up to the design rainfall conditions (56.4 mm over 5 days). At the July inspection, SB2 was holding water. However, due to the increase in total capacity during the reporting year, the minimum required water storage capacity for the rainfall conditions specified in Condition O4.3 of EPL 13172 was maintained (refer to **Photo 7.1**). Quarry management confirmed that sediment dams and silt cells are regularly excavated to remove consolidated silt which is transferred to drying cells for eventual use in rehabilitation.

**Photo 7.1** SB2 was observed to hold water at the July inspection, but the nominated storage capacity was maintained in compliance with the SWMP
